White River Streambank Restoration Project (FY 09 - 1900)

The Watershed Conservation Resource Center (WCRC) worked with project partners to stabilize a riverbank on the White River near Fayetteville, AR. A stabilization plan was developed and implemented for the eroding bank which was contributing an estimated 11,000 tons of sediment per year to the White River. Beaver Reservoir is located only a few miles downstream of the project site. The project was funded by an Environmental Protection Agency Section 319(h) grant administered by the Arkansas Natural Resources Commission with matching funds provided by the City of Fayetteville and other project partners. The project was initiated January 2011 and completed April 2012.

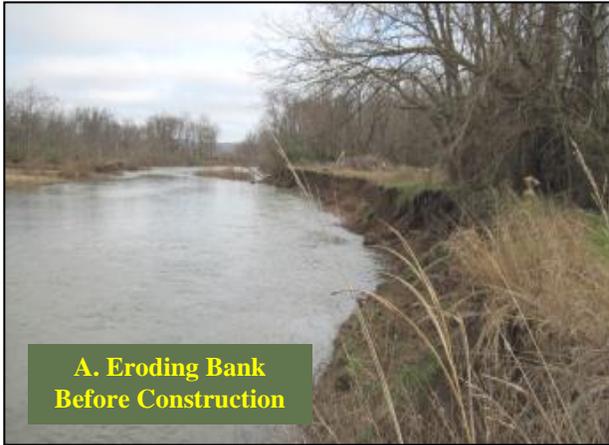
**A. Eroding Bank
Before Construction**

Background and Streambank Erosion: The White River, located in Northwest Arkansas, eventually forms Beaver Lake, which is the primary drinking water source for over 400,000 people in Northwest Arkansas. The Arkansas Department of Environmental Quality placed the White River on the 1998 State 303(d) list of impaired waterways citing sedimentation and turbidity issues as a result of surface erosion, which includes streambank erosion, as the cause. The project is located on a section of the White River that remains on the impaired list in 2012. The project tasks included measuring the lateral streambank erosion rate at the project site. Based on the data collected, the bank was retreating at a rate of approximately 14 ft/year and generating an estimated 11,000 tons of sediment, which was contributing to high turbidity levels. The erosion of the riverbank also contributed nutrients to the waterway, and 10,500 lbs/yr of total phosphorus was estimated to be generated from the severe streambank erosion.

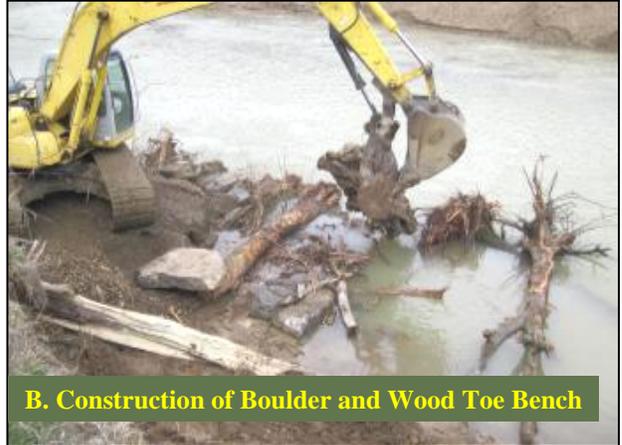
B. Construction of Boulder and Wood Toe Bench

Design & Implementation: The WCRC utilized natural channel design principles to reduce streambank erosion and sediment loads. Approximately 1000 feet of streambank was improved at this site that included constructed 500 feet of 'toe-wood.' The toe-wood structure was constructed using large trees, boulders, and gravel and was built outward, with a maximum width of 40 feet, from the existing eroded bank at two distinct levels or benches that allow flood waters to spread out. Trees used in the structure were donated from a nearby highway project. The exposed root wads and boulders at the water's edge provides excellent fish habitat and reduces the power of the passing floodwaters. A portion of the river channel was excavated to offset the lost capacity that resulted from construction of the toe-wood bench. Soil mattresses, a soil layer consisting of topsoil wrapped in a coconut fiber blanket, were constructed on each level of the toe-wood bench. The soil mattresses or lifts provide a medium for plants to take root and additional weight to secure the trees used in the structure. They were seeded with a mix of native plant riparian seed suitable for the local Ecoregion. Over 700 native plants (potted) including Alder, Witch Hazel, False Indigo, Blackhaw Viburnum, and American Beauty Berry, to name a few, were planted with help from volunteers. Also, several hundreds of river oat plugs, willow whips, and sycamore and button bush cuttings were incorporated into the benches. As plants mature, they will help to bind the structure together through root growth and they will also help to dissipate water velocity as the leaves, branches, and stems of the plants interact with the flooding river. An irrigation system was designed and installed and is being used to help insure the survival of the planted vegetation during the maturation process. In addition, over an acre of pasture land adjacent to the streambank restoration was converted to riparian vegetated with native grasses, shrubs, and trees.

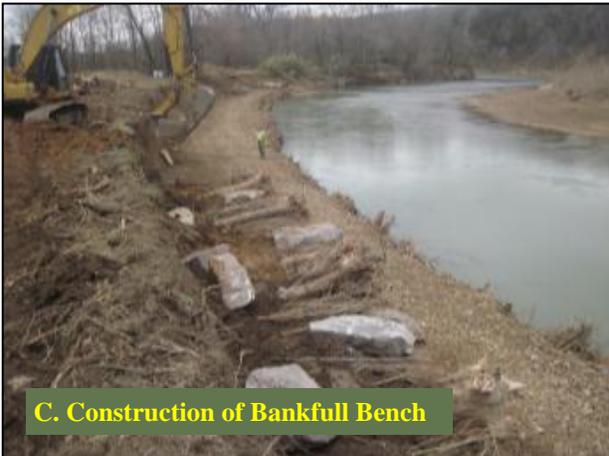
C. Construction of Bankfull Bench

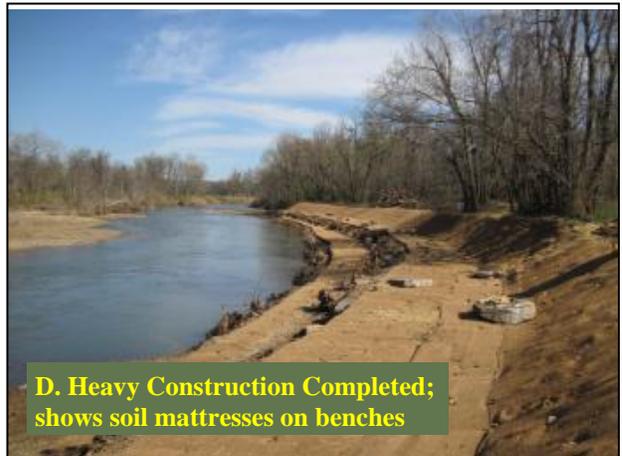
**D. Heavy Construction Completed;
shows soil mattresses on benches**

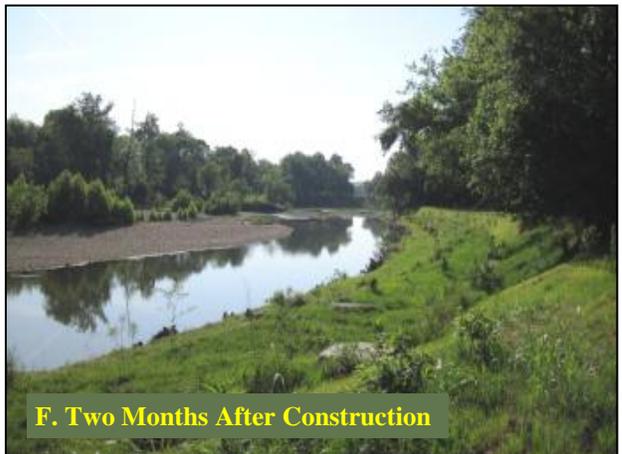
F. Two Months After Construction

Post Restoration: Although only recently completed, the stabilized bank is providing water quality benefits. A flooding rain event took place one week after the heavy construction phase of the implementation plan was completed. Inspections conducted after this flood indicated that no erosion occurred along the previously eroding riverbank. Prior to this project, the same event would have resulted in significant erosion releasing several thousand tons of sediment into Beaver Lake watershed. A minimum of a 95% reduction of sediment and nutrient loads from this site is expected, annually. For more information on this project, visit the WCRC web site at www.watershedconservation.org or call the WCRC at (479) 444-1916.
